Electrodes – steam generator

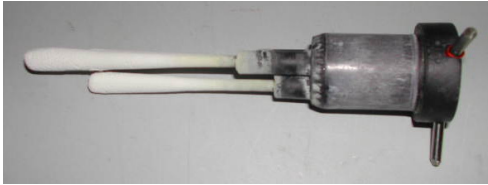
Non-functioning electrodes with deposit

If the steam head delivers no steam during the bathing cycle, but only water, the reason may be a build-up of deposits on the electrodes in the steam generator. To rectify this problem, it is necessary to clean the electrodes with a dry cloth or a piece of paper. The rubber tubing that leads from the electrodes to the water tank should also be cleaned. The illustrations below show the process in detail.

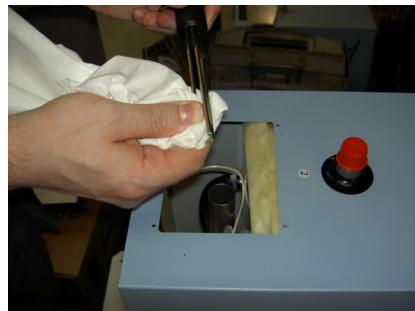
4. Using a dry cloth, a piece of clean paper or steel wool, carefully clean the electrodes until all traces of the deposit have been removed.
